Residential Mercury Spills from Gas Regulators

Many older homes are equipped with mercury-containing gas regulators that reduce the pressure of natural gas in the mains to the low pressure used in home gas piping. Removal of these regulators can result in elemental mercury spills inside the home. In the summer of 2000, mercury spills were discovered in the basements of several Chicago-area homes after removal of gas regulators by gas company contractors. Subsequent inspections of approximately 361,000 homes by two northern Illinois gas companies showed that 1,363 homes had residential mercury contamination. Urine mercury screening was offered to concerned residents, and results of urine bioassays and indoor mercury air measurements were available for 171 homes. Six of these 171 homes (3.5%) had a cumulative total of nine residents with a urine mercury ≥ 10 $\mu\text{g/L}$. The highest urine mercury concentration observed in a resident was 26 $\mu\text{g/L}$. Positive bioassays were most strongly associated with mercury air concentrations > 10 $\mu\text{g/m}^3$ on the first floor [odds ratio (OR) = 21.4; 95% confidence interval (CI), 3.6–125.9] rather than in the basement (OR = 3.0

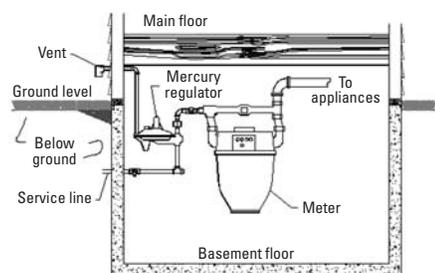
Figure 1. Diagram of a typical inside mercury regulator and meter set.

Before 1961, many homes in northern Illinois were equipped with gas meters connected to mercury-containing gas regulators. On average, these regulators contained about 136 g (2 teaspoons) of elemental mercury in a small cup. The purpose of the regulator was to reduce the pressure of the natural gas in the mains to the low pressure used in home gas piping. The mercury acted as a seal to the relief vent in the event of a pressure surge. As technology progressed, newer gas regulators were developed that did not use mercury. A diagram and photograph of a mercury-containing gas regulator are shown in Figures 1 and 2.

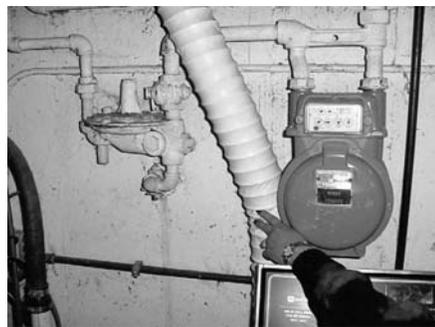
Figure 2. Photograph of a mercury regulator in a basement.

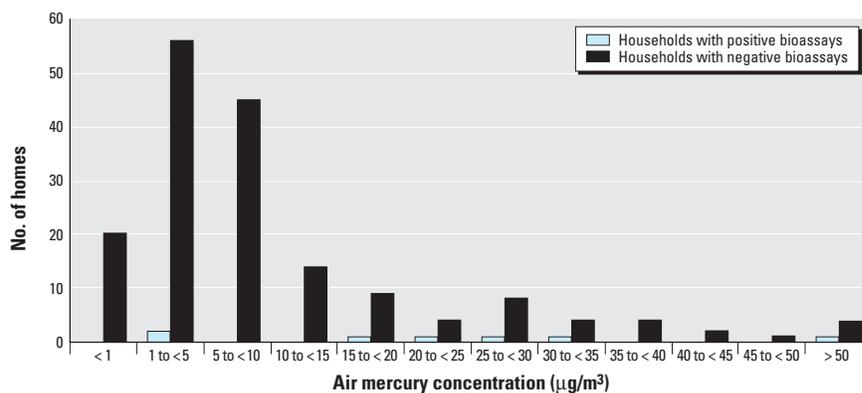
Figure 3. Distributions of mean air mercury concentrations for households with and without positive bioassays. Households with a positive bioassay were those in which ≥ 1 residents had a urine mercury concentration $\geq 10 \mu\text{g/L}$.

Urine mercury results for 625 individuals were provided to the IDPH. Of these, 420 were identified as residents of 171 homes for which mercury air monitoring data were also available. A positive mercury bioassay was defined as a 24-hr urine mercury concentration $\geq 10 \mu\text{g/L}$. Nine of the 625 residents (1.4% of residents) from 6 of these 171 homes (3.5% of homes) had positive bioassays. These positive bioassays ranged from 10 to 26 $\mu\text{g/L}$. The frequency distribution of the mean air mercury concentration and urine bioassay results (households in which at least one resident had a urine mercury concentration $\geq 10 \mu\text{g/L}$) in these monitored households is presented in Figure 3.
